Historic England

# Church Roof Replacement Using Terne-coated Stainless Steel

Guidance Note

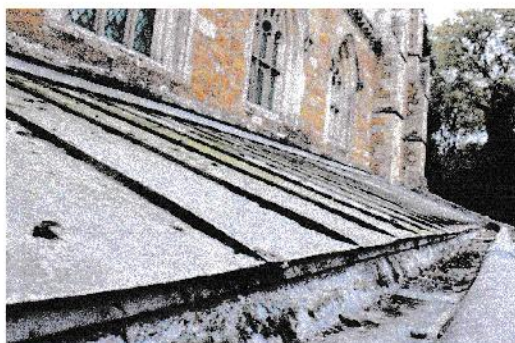
Standing seams

The 25 mm high standing seam has a double welted top. The minimum finished slope for this type of joint is 5°. In some exposed locations with long shallow slopes water has found its way through the seams by capillary action or potentially by wind and thermal pumping action. This phenomenon is a result of wind pressure and temperature changes on partially sealed seams. Many contractors now apply a butyl seal within the seam before closing up. However the seal, which is inaccessible once the roof is properly formed, can have a relatively short life expectancy of typically 10 years.

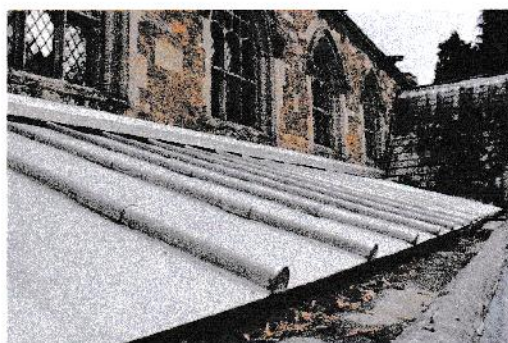
Round-batten rolls

The alternative side joint is to form a batten roll detail. The minimum finished slope for this type of joint is 3°. The sides of each stainless steel pan are dressed over a 50 x 50 shaped timber batten. The sides are 40 mm high with less risk of rainwater entry, whilst allowing the joint to breathe. Battens can be formed in different shapes. The round batten roll with a stainless steel cap batten closely resembles the traditional lead roll. An alternative preferred by some architects is a square batten with the capping held in place with welted edges, although this does not replicate the appearance of a traditional lead roll. Stainless steel cleats hold the sheets down and prevent detachment of the lightweight material in strong winds. The means of attachment also allow long lengths of sheet metal to expand and contract along the length of the roof slope. As there is less work hardening in forming the seams the risk of creating unevenness in the flat pan of the sheet, known as quilting or oil canning, is reduced.

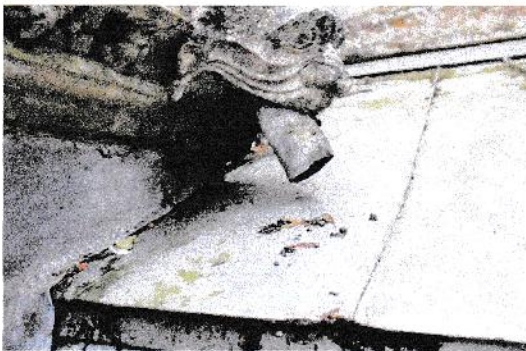
Awkward detail at verge with water running into upstand

Some rainwater ingress has been observed at verges and below sloping valleys where it has not been possible to site form and dress irregular shaped panels in stainless steel. This could be resolved by preparing a special panel in a workshop. Alternatively for relatively small areas the detail work around roof edges could be formed in lead. It is recognised that this could be attractive to a thief, although on a typical roof more than 95% of the roof area would still be formed in the terre coated stainless steel.

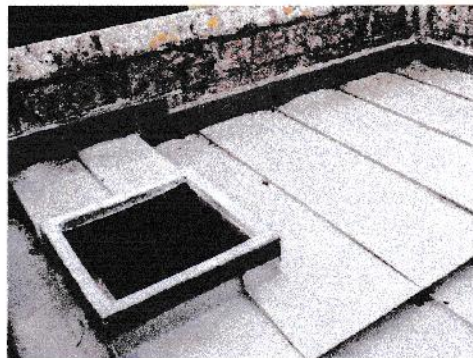
Lead used for flashings and access hatch capping

Other awkward details such as around pipe penetrations and access hatches could also be formed in lead. Lead remains the preferred material for flashings dressed into masonry. Where possible standard details should be adopted and agreed in advance.

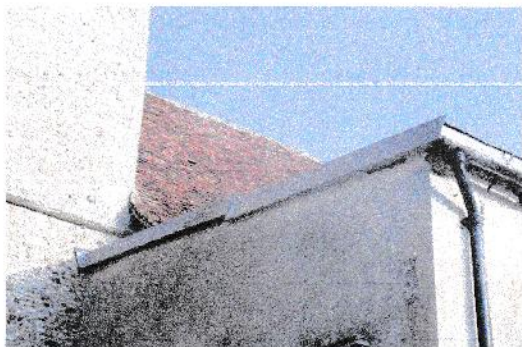
Straight verge fascia contrasts with uneven masonry

On occasion perimeter detailing to the stainless steel roofing can be readily seen from ground level and if not properly considered can give an unacceptable appearance.

Care is required in considering perimeter details that can be seen from ground level. Alternative details using traditional materials such as stone or rendered masonry may be feasible. Alternatively forming the verge in lead could be considered, although again this could be attractive to a potential thief.

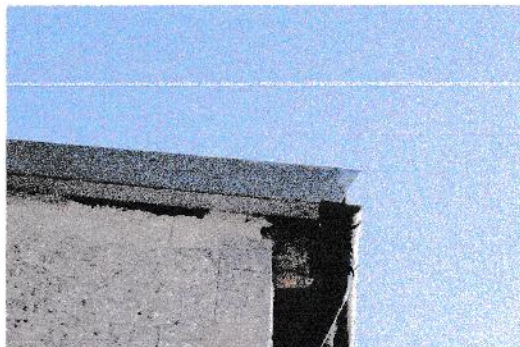
End of fascia with acute corner and incomplete closure

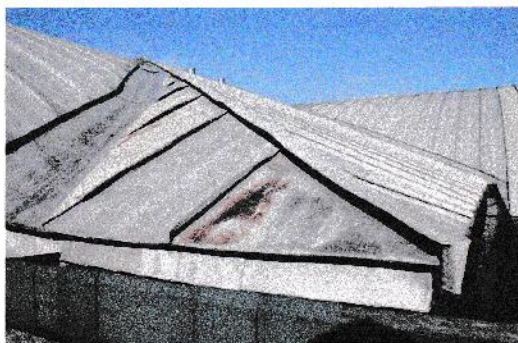
Discolouration of lead rich terne coated stainless steel

On a few stainless steel roofs with the old lead / tin terne coating a brown coloured residue formed after several years of exposure. On investigation it was found that there was no reduction in the overall thickness or pitting corrosion in the stainless steel roofing. Trials have shown that the discolouration can be permanently removed using a weak phosphoric acid solution that is commonly found in carbonated soft drinks, especially cola.

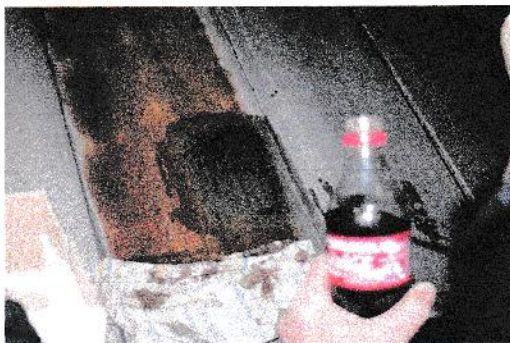
Stain successfully removed using weak phosphoric acid solution
